DEPARTMENT OF TRANSPORTATION

Caltrans Quality Assurance (QA) Inspector, Larry Viars was present observe production welding of the deck plate U-rib splice welds and perform random Visual Testing (VT) of the Orthotropic Box Girder (OBG), for the San Francisco Oakland Bay Self Anchored Suspension Bridge, at Zhenhua Port Machinery Company (ZPMC) facility on Changxing Island.

WELDING INSPECTION REPORT

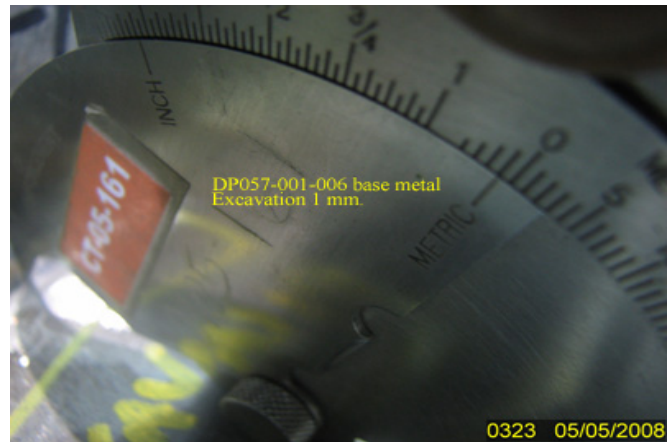
The Caltrans QA Inspector performed visual inspection of OBG 8.565 meter deck panel DP057-001 (welds 001 through 007) U-rib Partial Joint Penetration (PJP) welds. ZPMC performed visual inspection then immediately performed grinding of the discontinuities marked. Visual testing of welding was performed in accordance with contract documents. The following discontinuities were found during inspection on the Submerged Arc Welding (SAW) cover pass, incomplete fusion, overlap, undercut, underfill and oversize welds. Welding discontinuities were marked on deck panel with a permanent marker, length and Y location recorded. Visual Inspection results were distributed to the appropriate personnel for review. An excavation area on weld 006 in the deck plate was found measuring approx. 1 mm in depth, please see pictures of the base metal excavation below. Please see the

attached photo of the above mentioned excavation area. The list below shows a summary of discontinuities found during visual inspection.
